UI Bulletin #154

Subject:	Upfit Body Mounting / Chassis Wiring Harness Routing
Models:	Chevrolet Silverado/GMC Sierra 3500 HD Cab Chassis Models only
Model Years:	2011 and Beyond
Date:	July 19, 2019
Revision Date	N/A

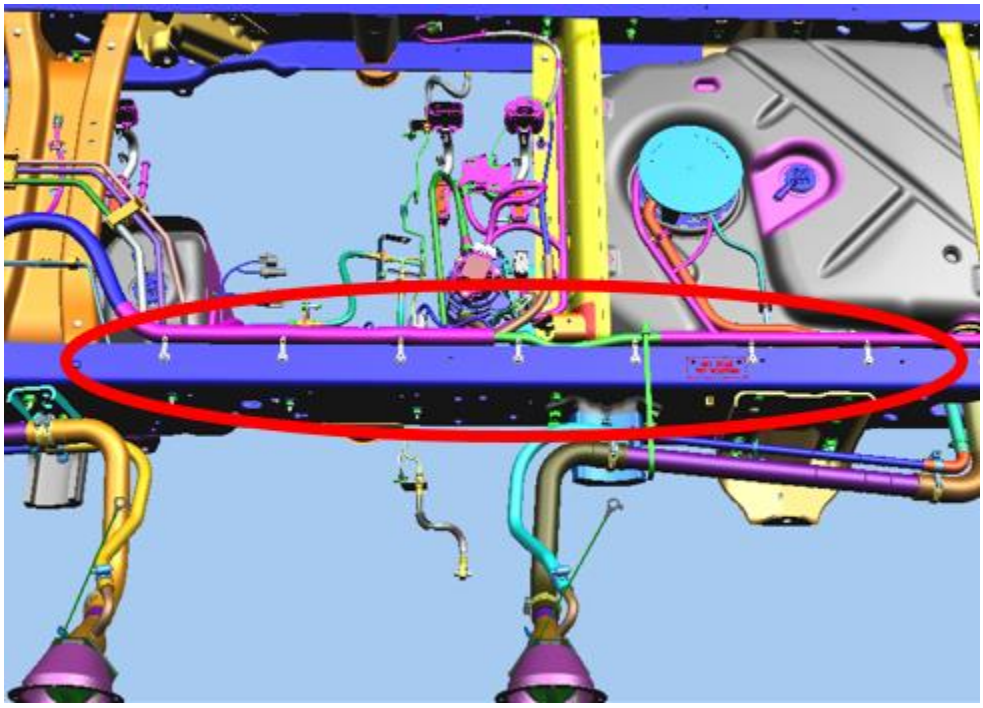
Figure 1 Harness Area of Concern

Care must be taken when installing upfit bodies on the rear driver's side chassis to allow clearance to wiring harness/attachments. Wiring Harness `Service Access' could be compromised when mounting an upfit body. Upfit Body mounting provisions should not pinch or lock in the OEM harness/attachments.

Upfit body mounting practices and provisions should allow for service of chassis wiring harness/attachments.

If the upfitter chooses to relocate the harness inboard, they're responsible for the proper securing and protection of the harness. Similar OEM harness support intervals should also be utilized. Care should be taken so harness does not chafe sensitive chassis lines, components and modules**.**
